Te Awa O Te Atua / Matatā Lagoon Water Quality, Ecology and Options for Improvement

Whakatāne District Council

Te Awa o te Atua / Matatā Lagoon: Water Quality, Ecology and Options for Improvement

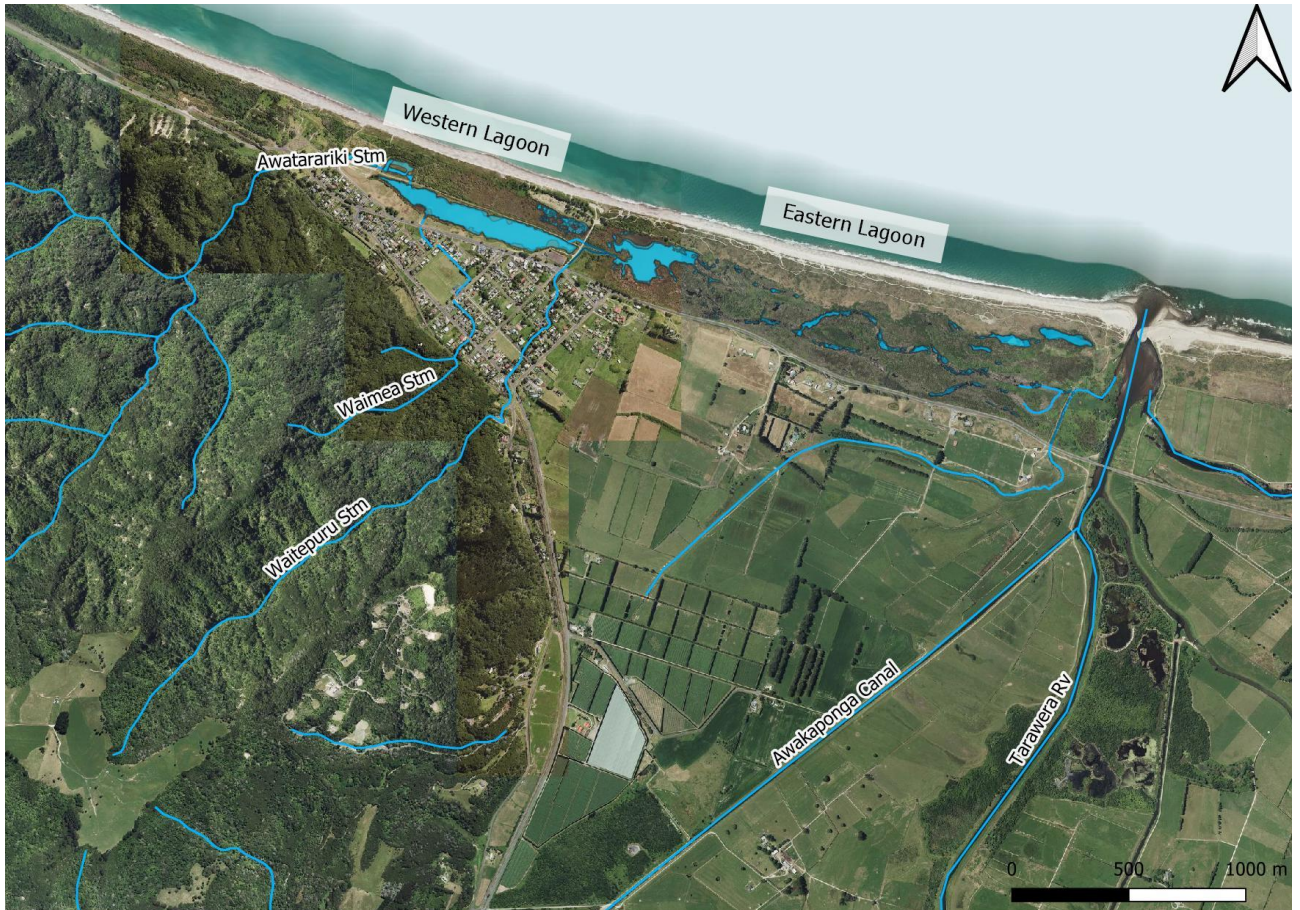
Figure 1.1: Location of Te Awa o te Atua / Matatā Lagoon and stream networks.

Te Awa o te Atua is located at Matatā, at the western edge of the Rangitāiki Plains. It is situated between Awaateatua Beach and State Highway 2, and extends from the Tarawera River mouth to Matatā township. Te Awa o te Atua is part of the Matatā Wildlife Refuge Reserve. Historically a riverine estuary of the Tarawera River, the lagoon is now broadly divided into the eastern lagoon and western lagoon by a causeway to the Matatā Recreation Reserve and camp ground (**Figure 1.1**).

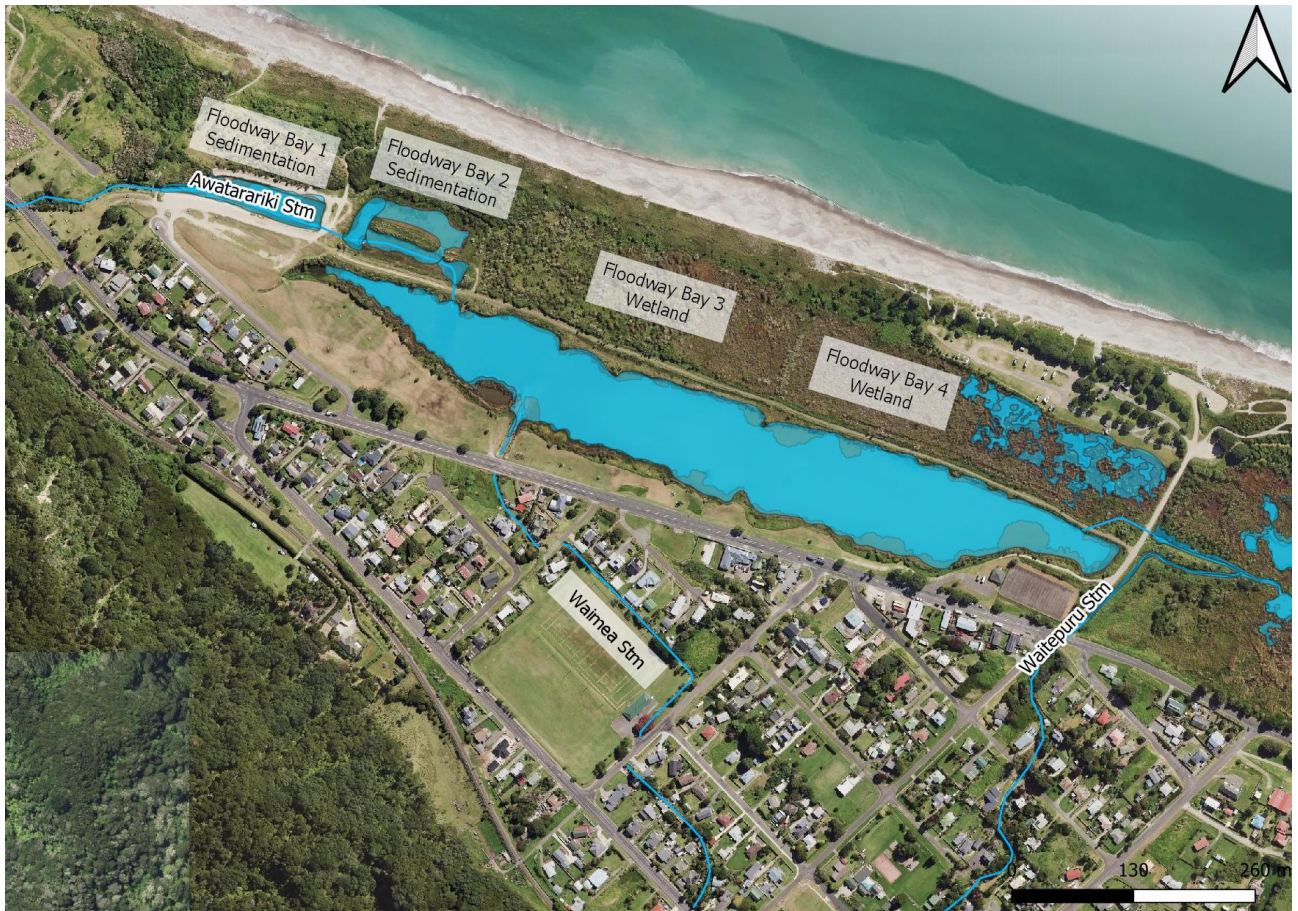
Figure 1.2: Western end of Matatā Lagoon / Te Awa O Te Atua, showing the open-water adjacent to Matatā township, and four floodway bays – two that settle sediment from the Awatarariki Stream and two dominated by raupō reedland (LINZ aerial image from 2022).

Rehabilitation works and a restoration programme following the 2005 event was largely completed by mid-2010. This provided for a smaller open-water western lagoon (c. 7 ha), and four floodway bays on the seaward side separated by embankments, two of these bays are dominated by raupō reed. The embankments and spoil areas were planted with about 44,000 native coastal and wetland plants, but aquatic emergent plants were intended to establish naturally to provide shelter and breeding sites for aquatic and wetland birds (Owen et al 2010) (**Figure 1.2, Figure 1.4**).

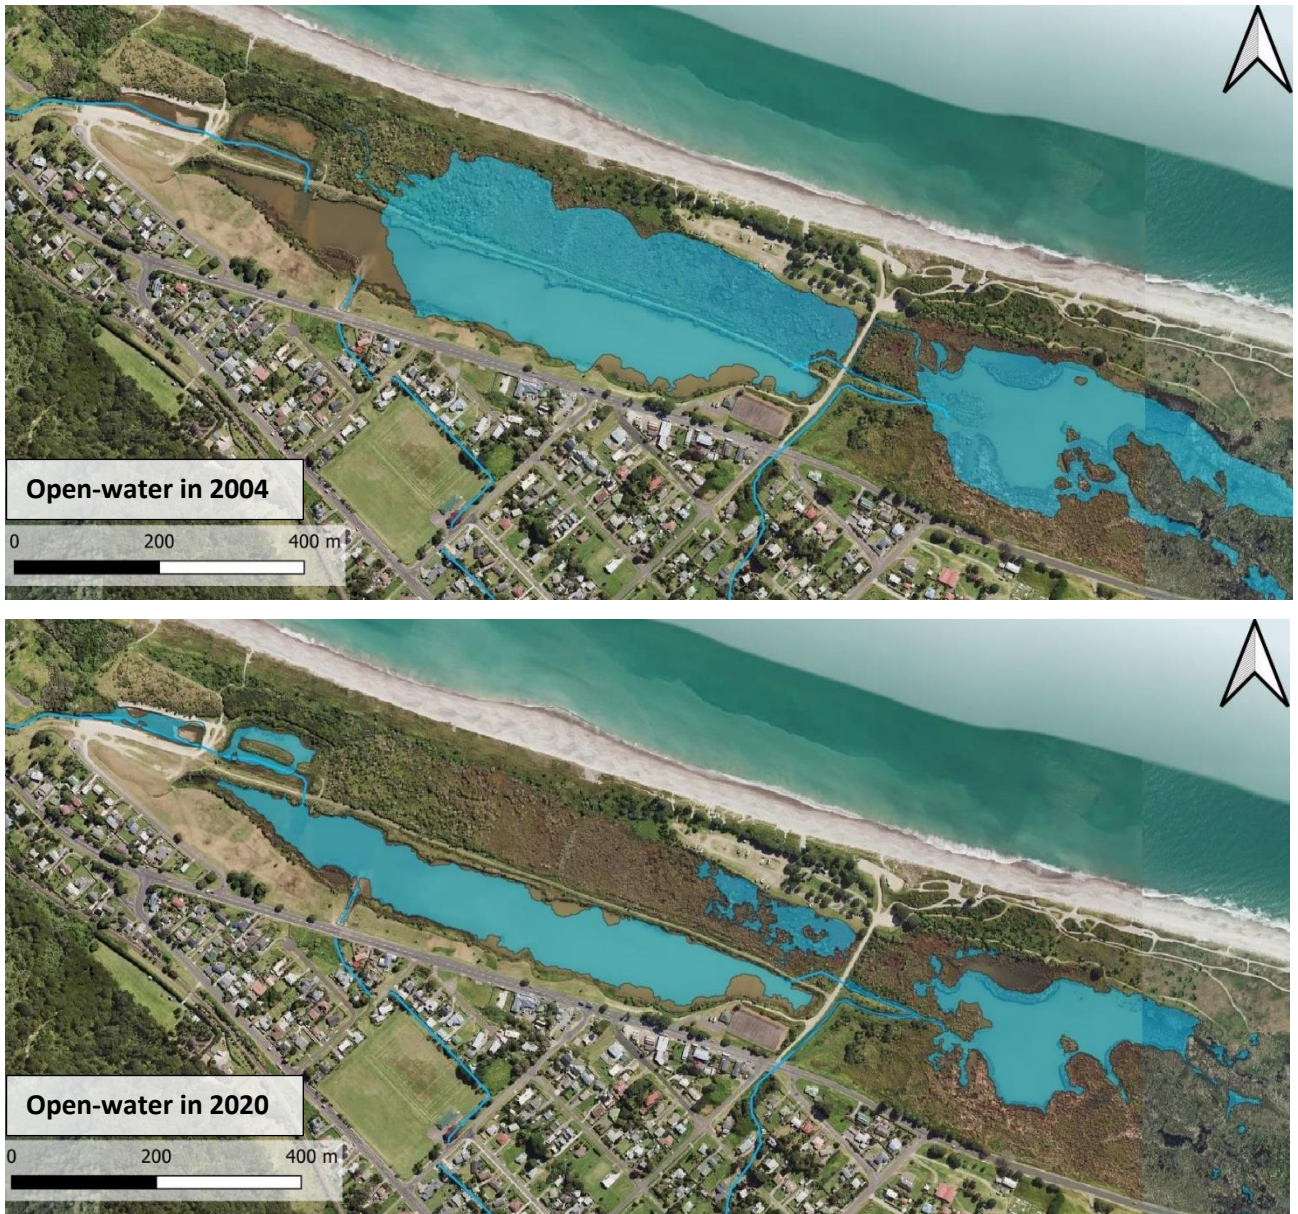
Figure: 1.4: Extent of open-water (blue) in the western Matatā Lagoon / Te Awa o te Atua in April 2004 (upper), and April 2020 (lower) compared to an aerial image from 2022. Note the expansion of raupō in the eastern lagoon and in the floodway bays wetlands, but the loss of raupō margins in 2021 from the western lagoon.

The objective of the ecological rehabilitation of the western lagoon was to revegetate indigenous coastal wetland and shrubland, and to re-establish some of the former open-water habitat (Boffa Miskell 2009). Earthwork cross-sections show the planned depth of open-water was about 0.8 to 1.5m with slightly deeper water on the southern side near Arawa Street. The western end of the western lagoon (extending east of the Waimea Stream confluence) was intended to regenerate into a shallow raupō wetland – the boundary between the shallow wetland and open-water corresponded to an area that was dominated by raupō wetland prior to the 2005 flood (**Appendix 2, Figure 1.4**).

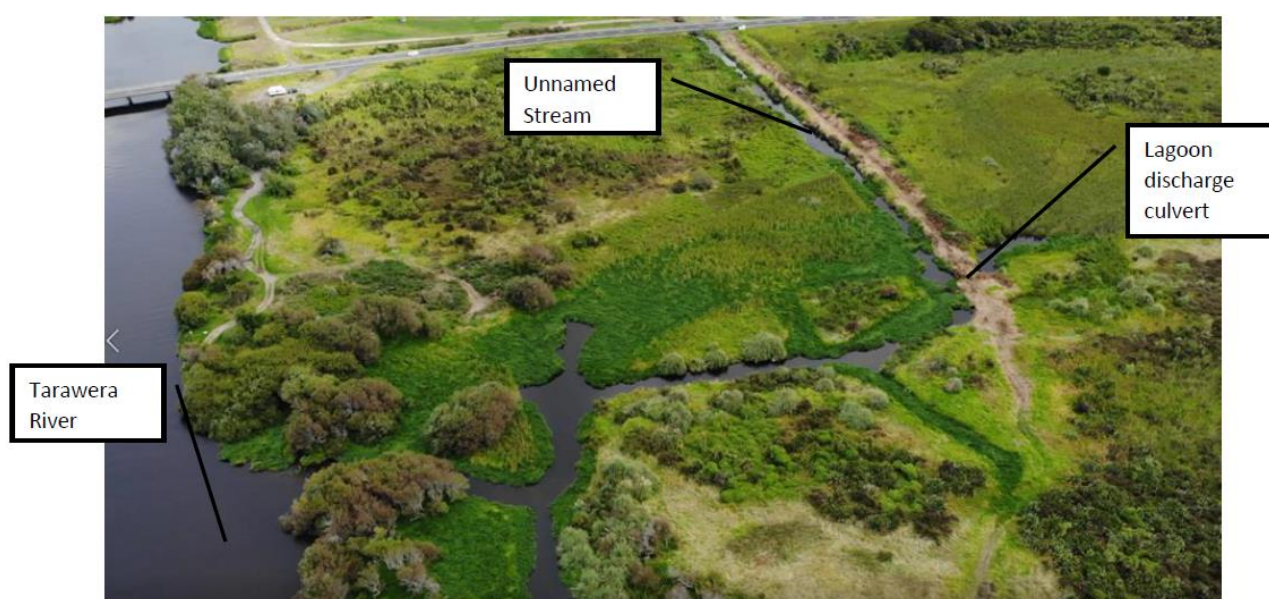
Figure 3.1: Outlet of eastern Matatā Lagoon to the Tarawera River (ATS 2019).

The eastern lagoon connects to the Tarawera River via a 1500mm culvert and unnamed stream (**Figure 3.1**)². This allows brackish water from the Tarawera River and sea to enter the eastern lagoon. Water level in the lagoon is maintained with a weir structure at the upstream end of this culvert. The weir was originally set to maintain a minimum water level of 0.67m RL Moturiki Datum, about 0.6m above the low tide level. However, in 1963 the lagoon level was raised by adding another stoplog to the outlet weir (Owen et al 2010).

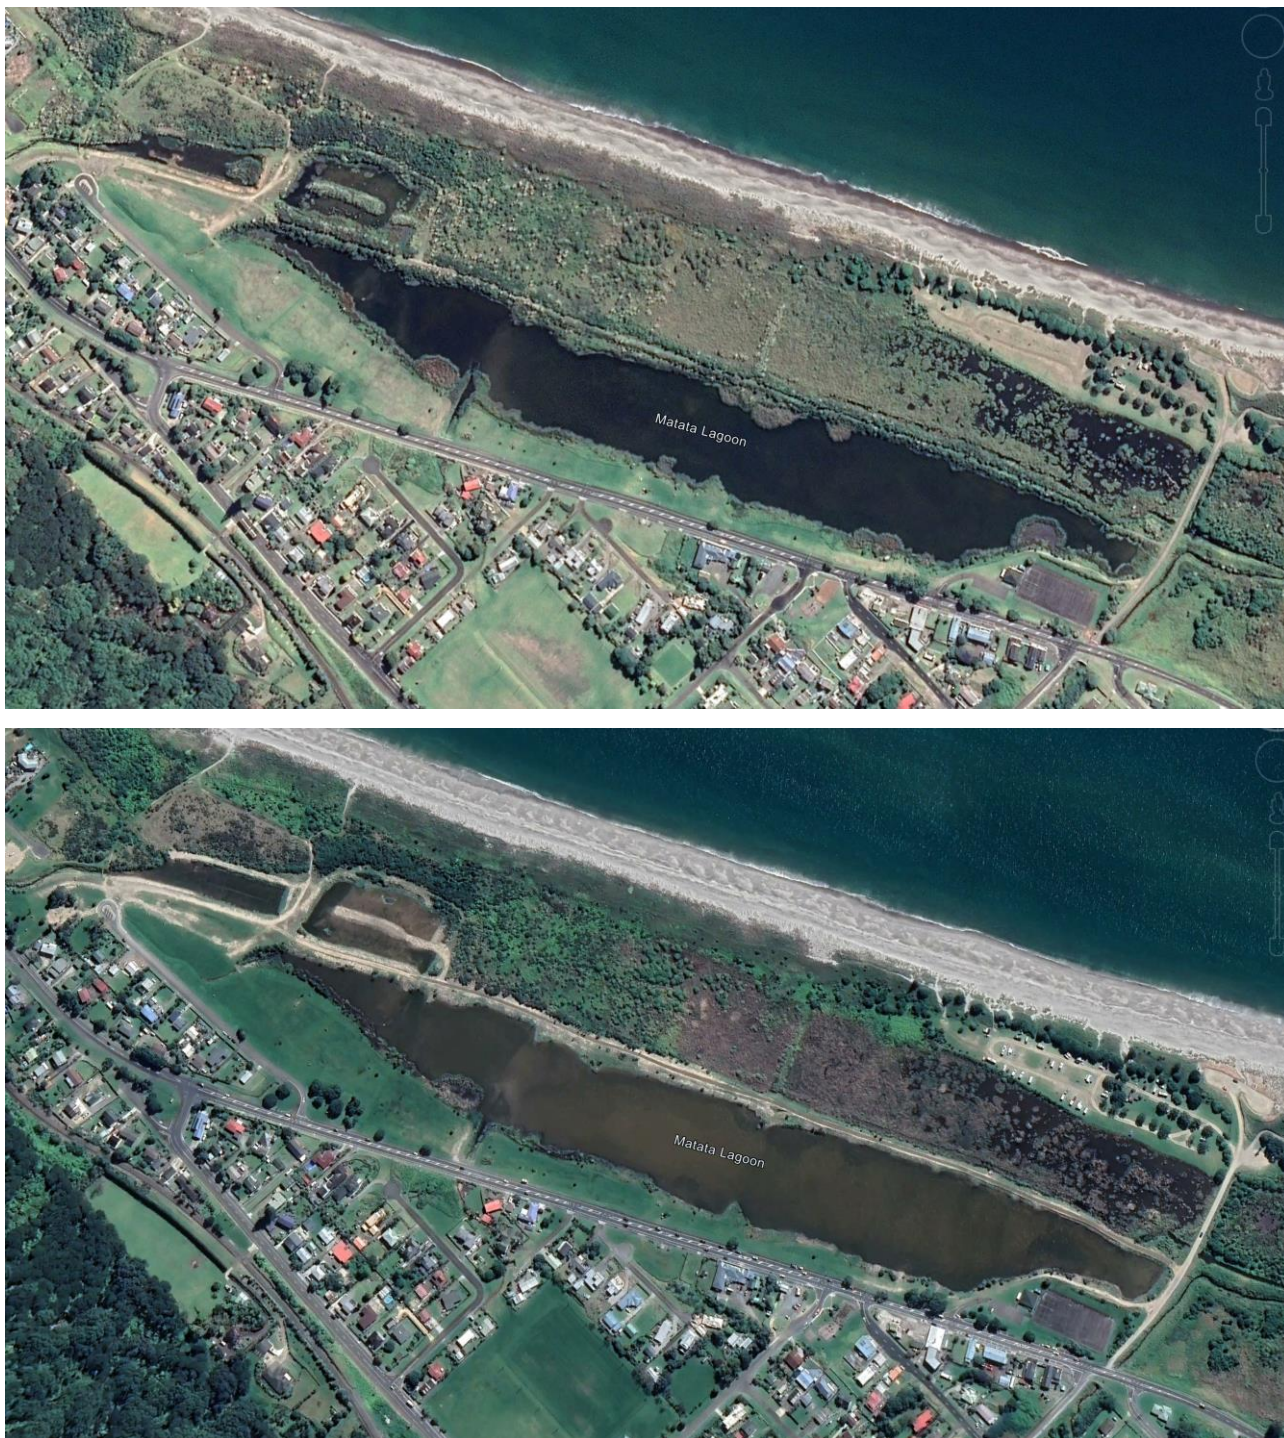
Figure 3.6: Western Matatā Lagoon in May 2021 (upper) and February 2022 (lower) showing the loss of riparian vegetation along the northern causeway and sedimentation bays, and the loss of raupō wetland margins from the open-water (images from Google Earth).

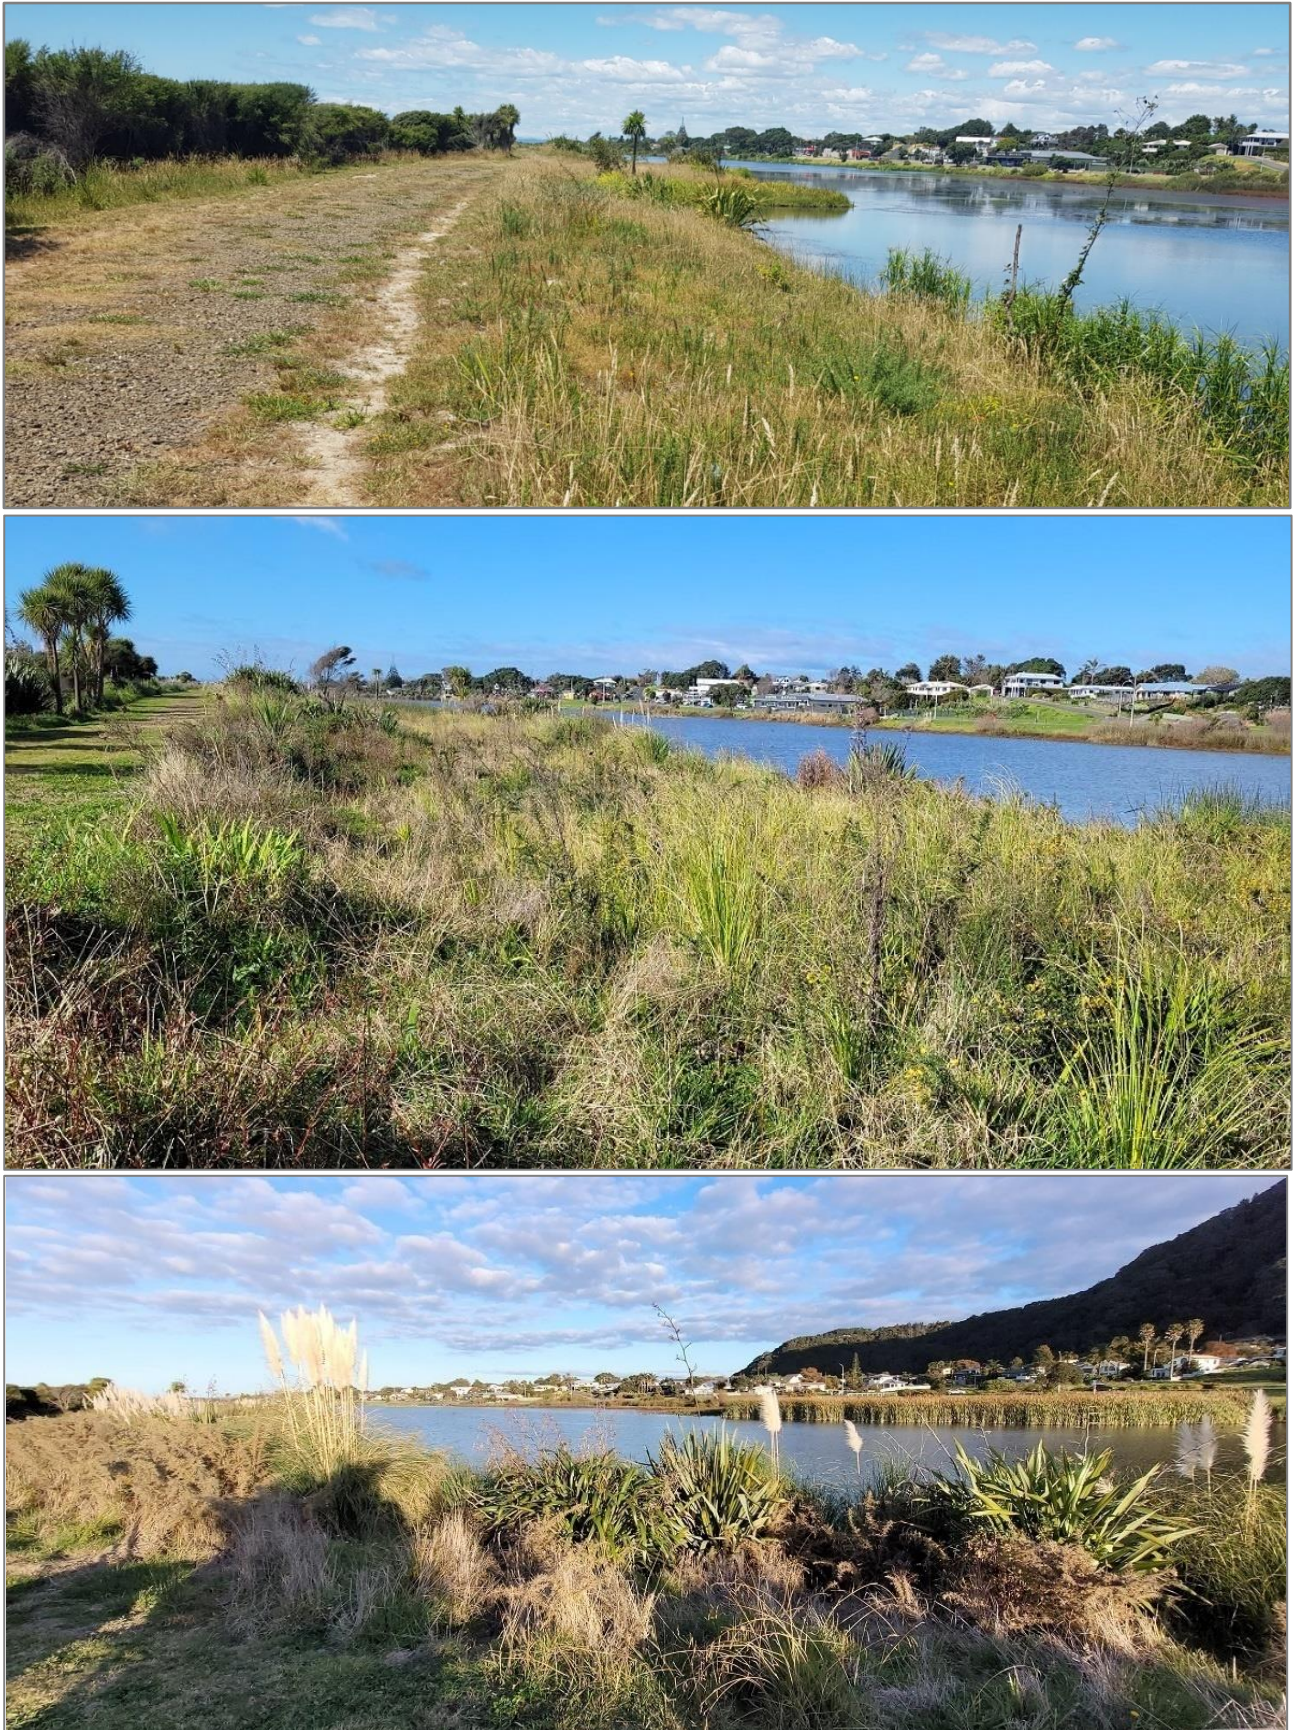
Figure 3.8: Western Matatā Lagoon walkway (facing east) showing gorse and pampas grass on the embankment (top, 2022_01, middle, 2023_07, lower, 2024_05 after gorse has been sprayed).

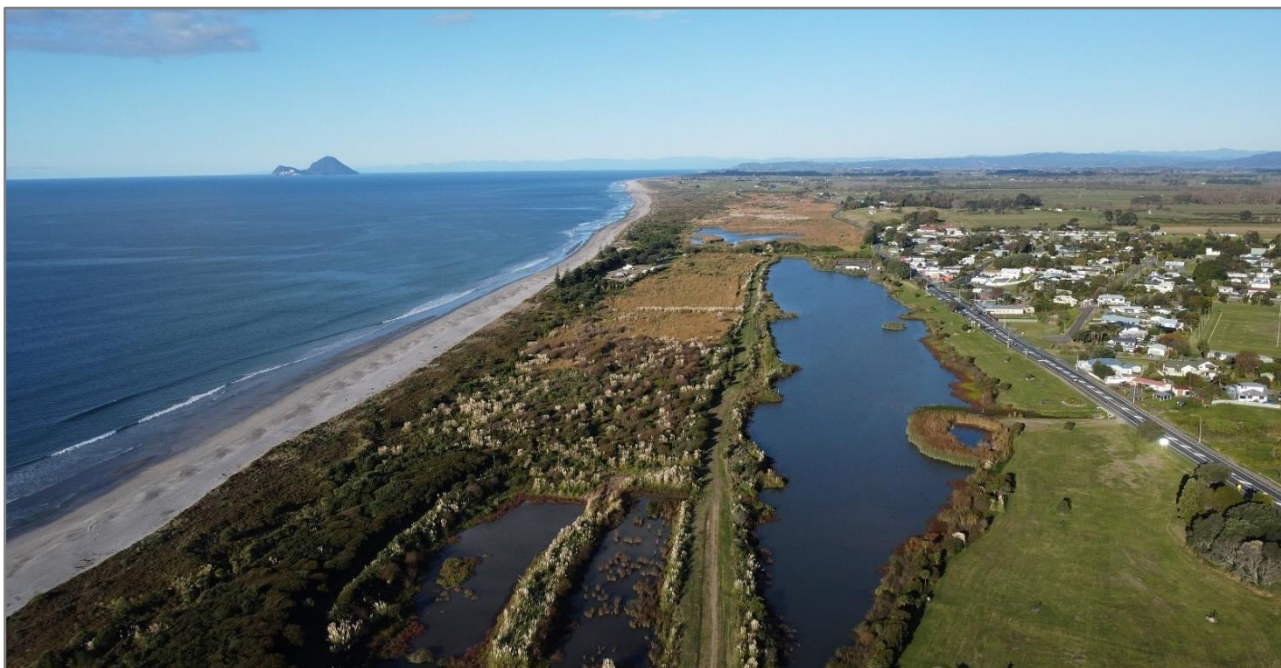
Figure 3.9: Western Matatā Lagoon (facing east) showing extensive cover of pampas grass with white flower heads in the sedimentation bay, western end of floodway bay 3, embankment separating the floodway bay 3 and 4, and along the edge of the walk way (May 2024).

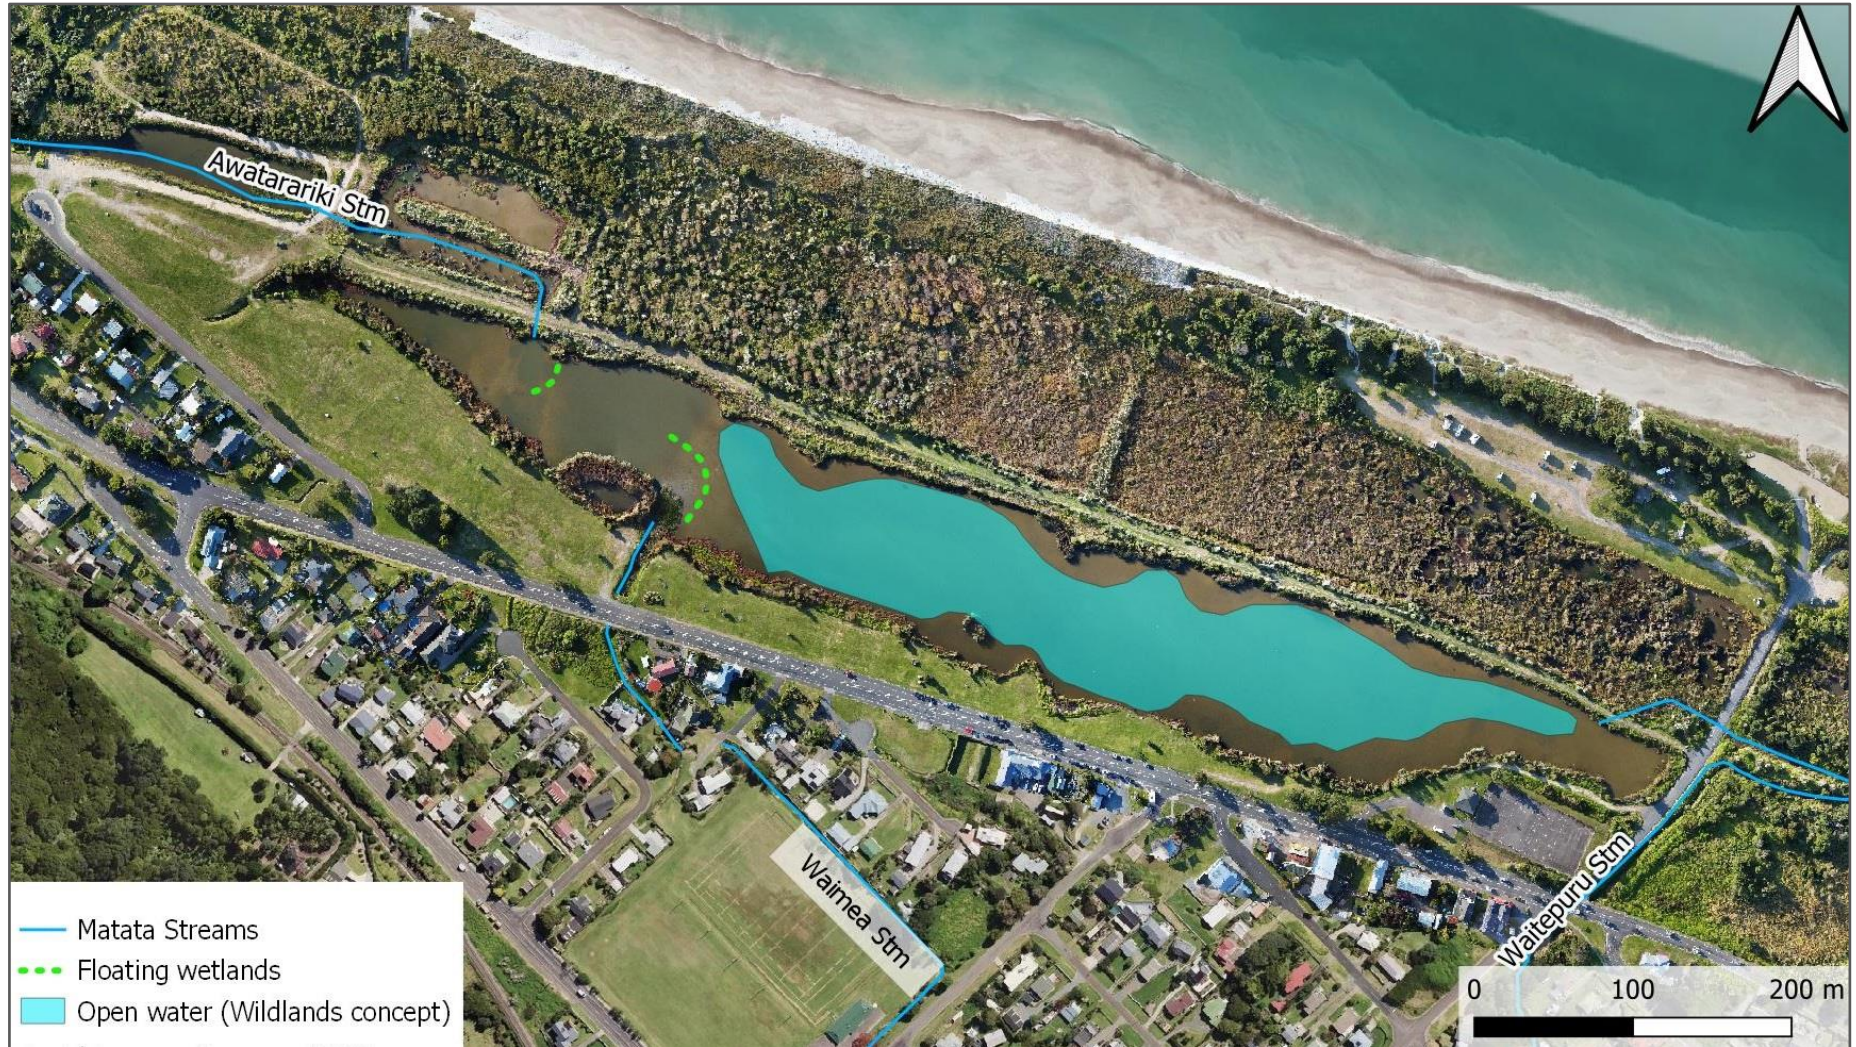
Figure 4.1: Western Matatā Lagoon showing approximate extent of open-water in concept plans for remediation works, and possible locations for floating wetlands. White flowers of pampas are visible along the walkway and in the western end of Floodway Bay 2, indicating areas requiring plant best control. (Aerial image, May 2024).

Figure 4.1 maps the proposed location of recommended actions in western Matatā lagoon relating to pest plant control, native planting, areas for aquatic emergent wetlands and possible areas for floating wetlands.

In the shallow water of Matata Lagoon, their root system will also influence water flow, so a string of floating wetlands near the Waimea Stream mouth could help direct where sedimentation occurs. This gives the opportunity to use floating wetlands to direct sedimentation towards the west to support expansion of shallow emergent wetlands in this area of the lagoon. An example of how floating wetlands could be placed in western Matata Lagoon is shown in **Figure 4.1**.

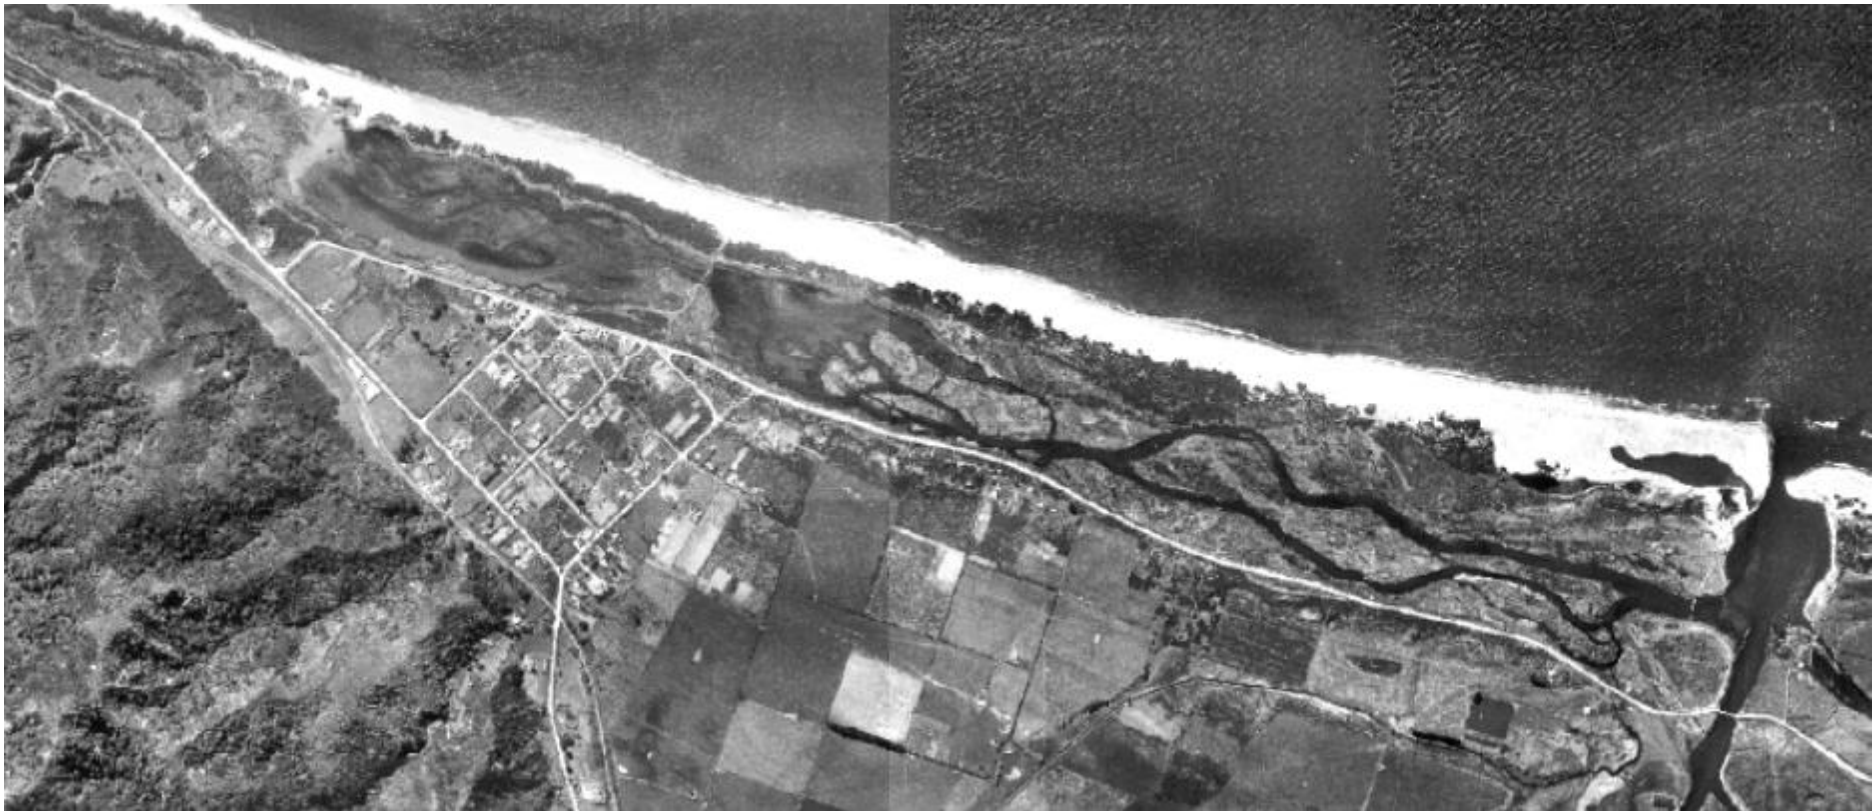
1943-1950

Images made available by a joint project between Local Government Geospatial Alliance (LGGA) and Land Information New Zealand (LINZ) - Retrolens Historical Imagry Resource.

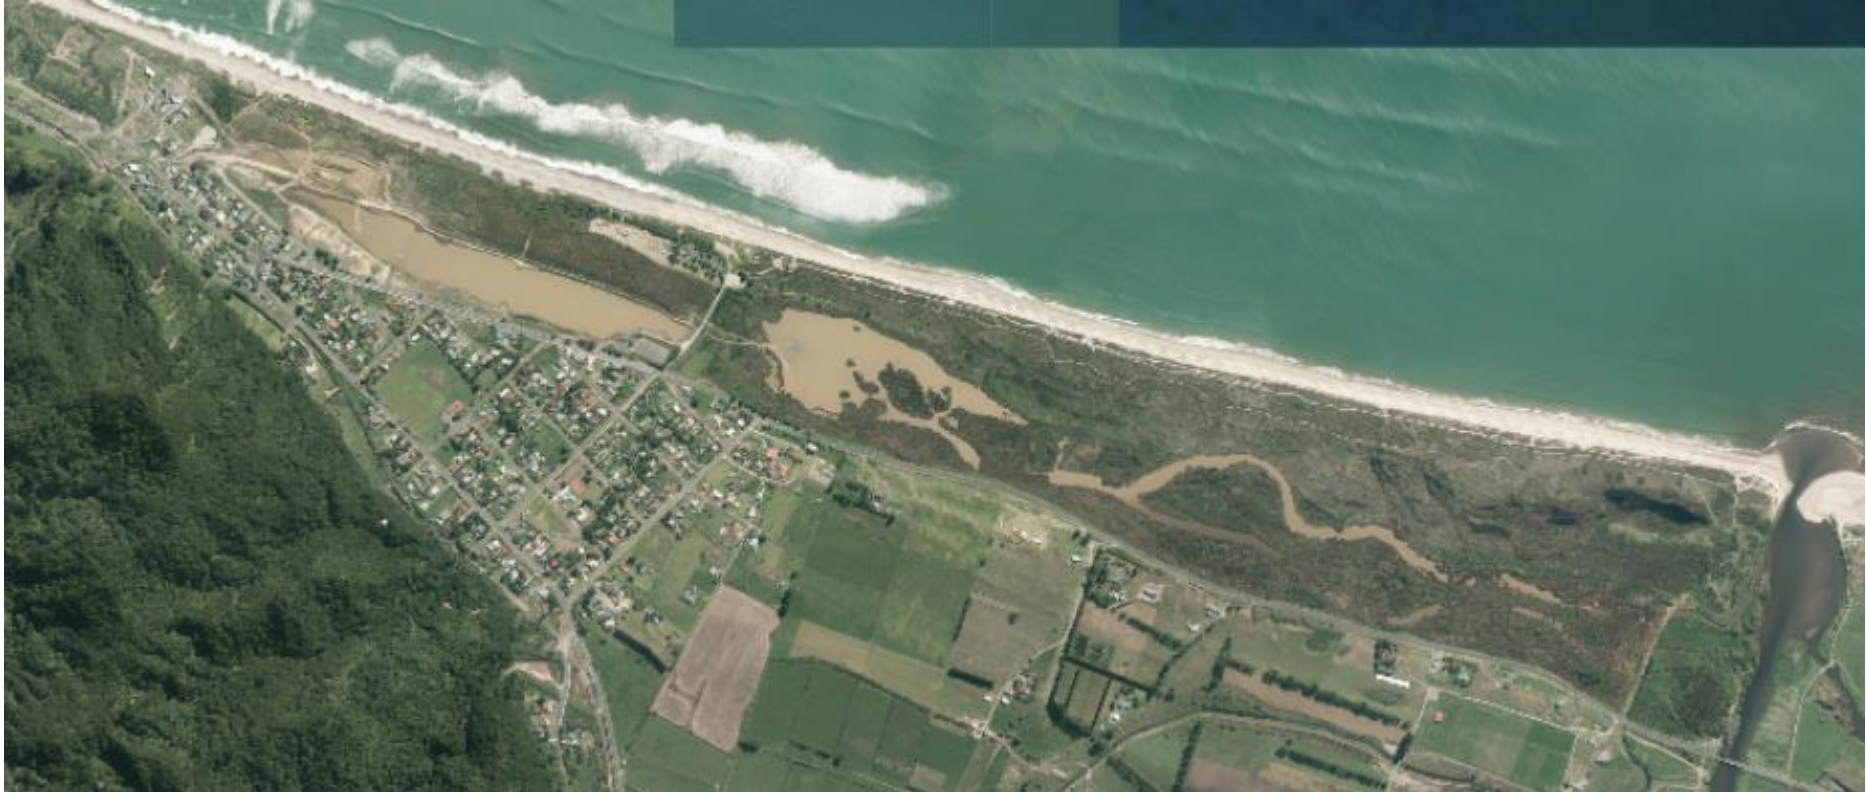
2011 (soon after completion of the earthworks for rehabilitation of the western lagoon)
